Manhole Inspection Summary

Manhole # S31A__017MH

Insp Date: **12/21/07 9:42 AM**

Location Address: **534 SAINT MARY ST**

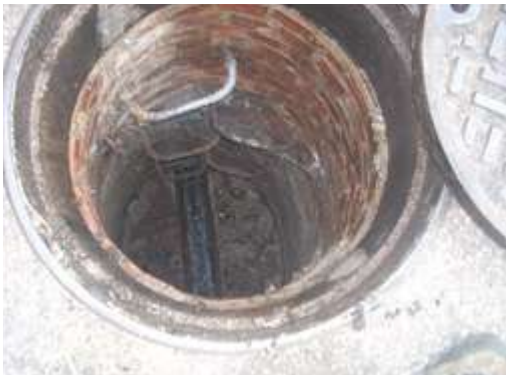
Defect 2

Steps Count: **5** Missing: **0** ☒ **Corroded**

CORRODED STEPS

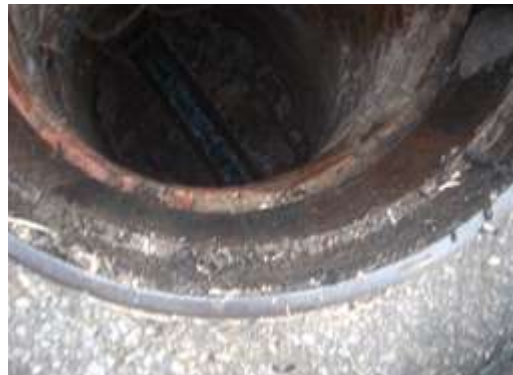
Defect 1

Frame Offset: **1** (in.) Condition: ☒ Sound ☐ Cracked ☐ Leaks

FRAME OFFSET

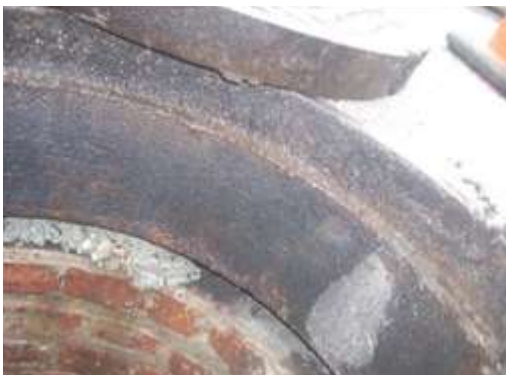
Defect 3

Corbel Material: **Brick and Concrete** ☐ Parged Type: **Concentric/Eccentric**

Condition: ☐ Sound ☐ Cracked ☐ Root Intrusion ☐ Loose Brick ☒ **Deteriorated**

CORBEL DETERIORATION

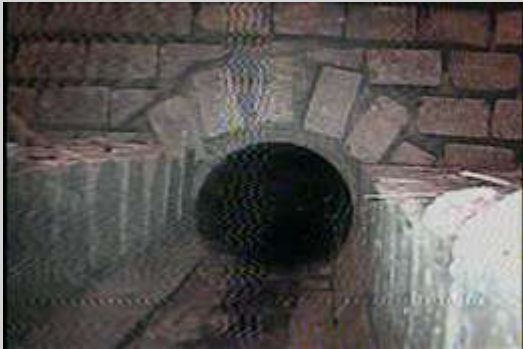
12 O'Clock Outflow

8 in. Circular Gravity Sewer
Pipe Out @ 12 O'Clock

Pipe Height: **8.4** (in.) Rod and Bar (Angled)
Pipe Material: **Clay** ☐ Pipe Lined
Invert Depth: **9.18** (ft.) Flow Characteristics: **Slow**
Deposits: ☒ None ☐ Mud ☐ Sludge ☐ Debris ☐ Grease
Silt Depth: (in.) Deposits Extent:
Infiltration: **None** Pipe Seal Cond: **Sound**

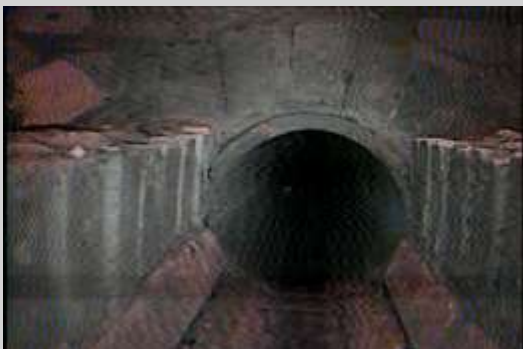
6 O'Clock Inflow

8 in. Circular Gravity Sewer
Pipe In @ 6 O'Clock

Pipe Height: **8.4** (in.) Rod and Bar (Angled)
Pipe Material: **Clay** ☐ Pipe Lined
Invert Depth: **9.08** (ft.) Flow Characteristics: **Slow**
Deposits: ☒ None ☐ Mud ☐ Sludge ☐ Debris ☐ Grease
Silt Depth: (in.) Deposits Extent:
Infiltration: **None** Pipe Seal Cond: **Sound**
